COMMONWEALTH OF MASSACHUSETTS
DEPARTMENT OF THE TRIAL COURT

SUPERIOR COURT
C.A. No. 03-1397-D

RYAN CARROLL; BIG PAPA'S LLC;
AND JOSEPH A. MARCUS, AS
TRUSTEE OF BIG PAPA'S REALTY
TRUST ,
Defendant(s)

AFFIDAVIT OF JAMES D'ANGELO, P.E.

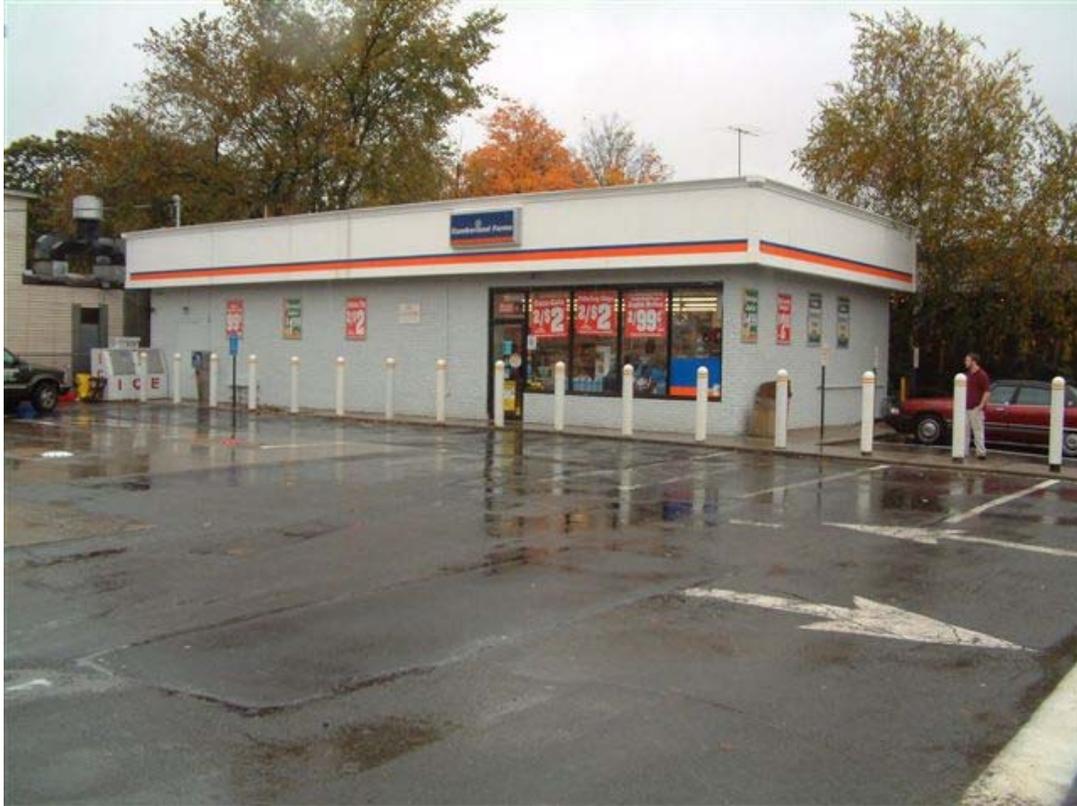
Photo 4

7. Multiple data sources have indicated that, prior to this accident, there had been several other accidents in the immediate area, presumably contributed to by the alignment and design of the intersection south of the subject parcel. In fact, about a year earlier, a vehicle left the roadway and caused significant damage to the building next door, which is shown in photo 4.
